## CASE STUDY | CLIENT: WATER DISTRIBUTION TEST FACILITY

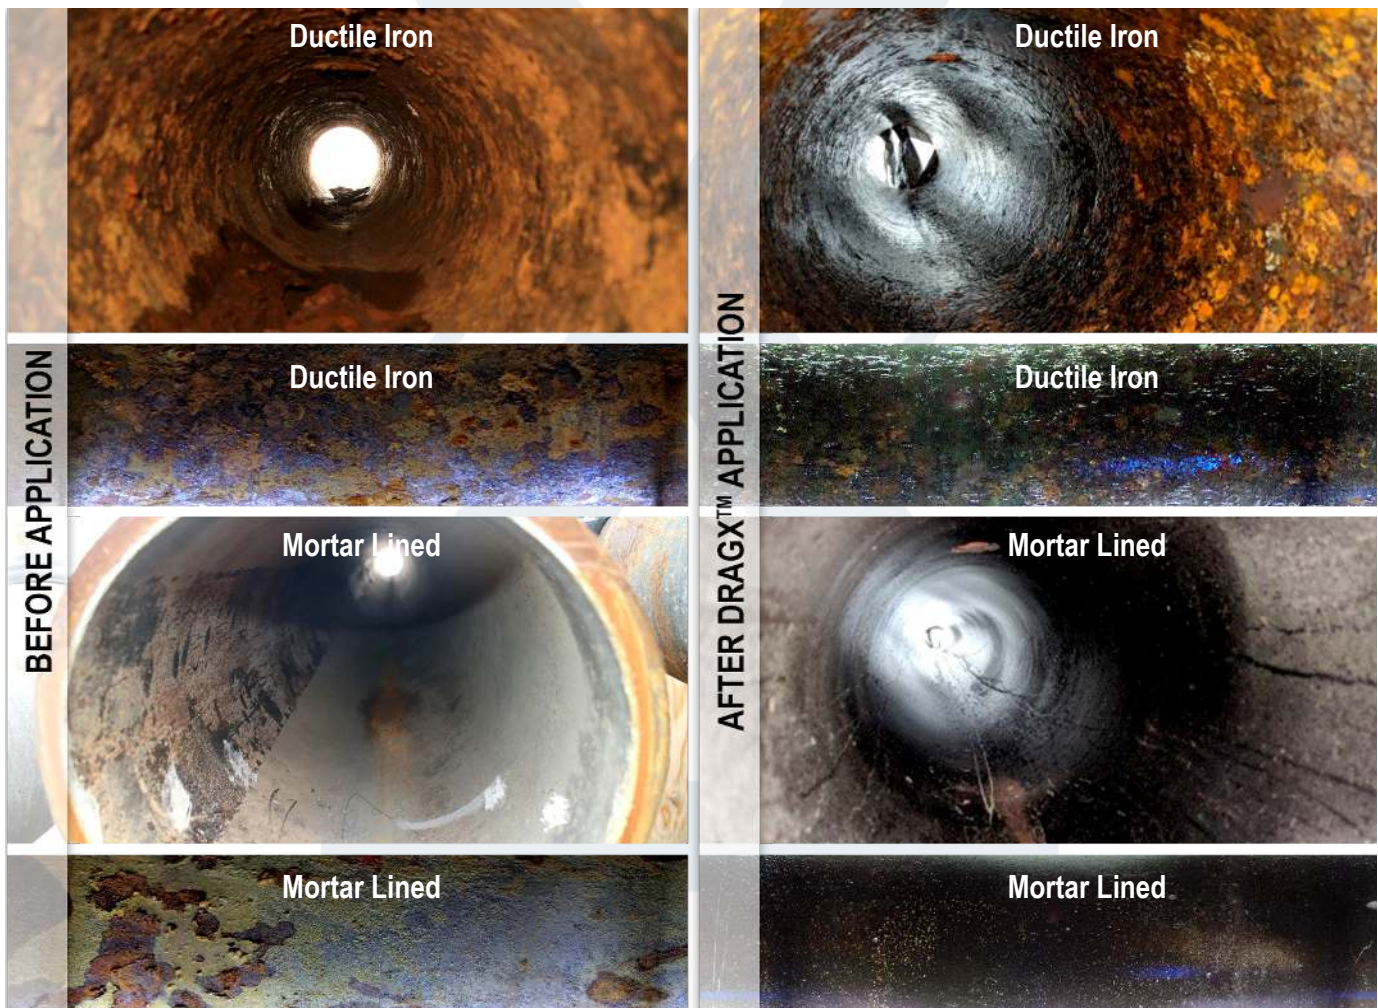
- Coat 8" diameter, reclaimed ductile iron and mortar lined iron water main pipes that had been cleaned after contamination
  - Pipe sections were heavily corroded and pitted with 20-40 years of service
- Coating must be compatible with water quality standards and sanitization protocols including exposure to chlorine flushes

- Cleaning and coating of the sections were completed within 3 days
- Pipe surface was coated with DragX™ to desired specifications
- DragX™ successfully sealed pipe surface pores to prevent residual contamination from ongoing fouling
- During the sanitization process, it was seen that DragX reduced chlorine uptake of the pipe walls by a factor of 3-4 during chlorination process, meaning that chlorine can be utilized much more efficiently after coating
