CASE STUDY | CLIENT: CHEMICAL HANDLING FACILITY

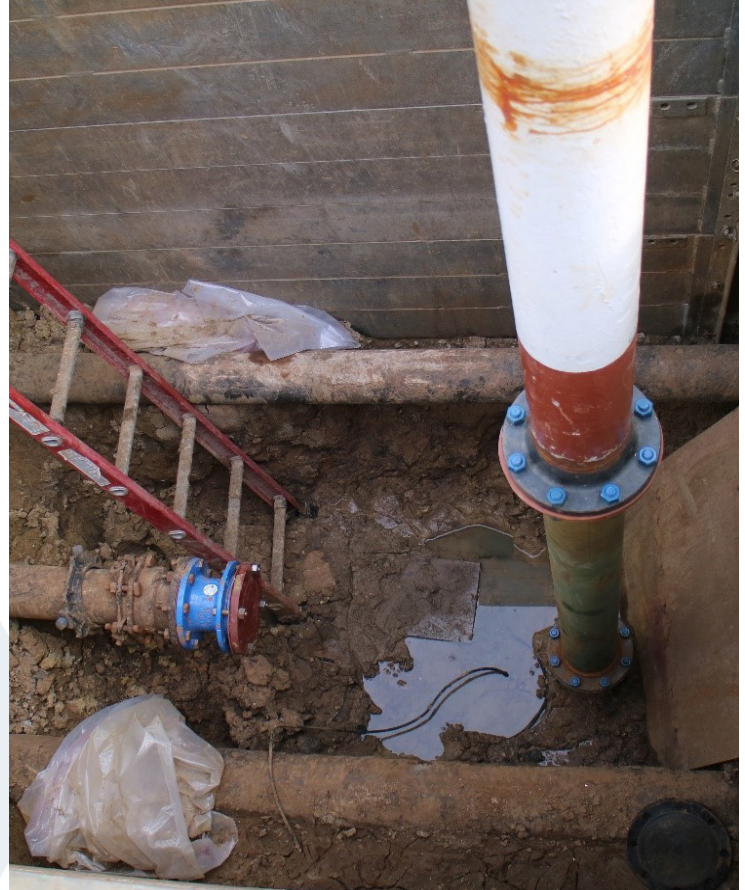
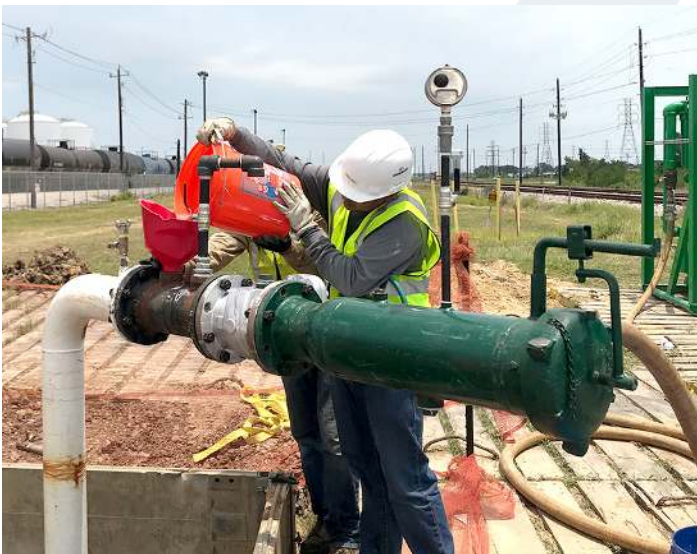
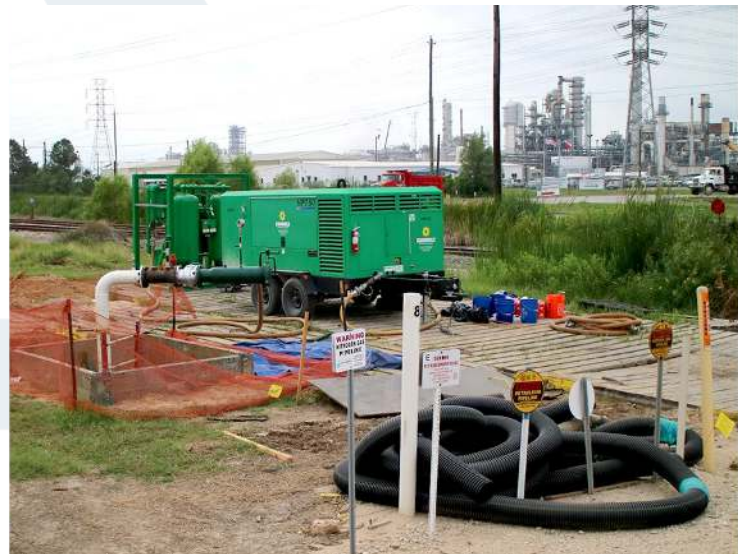
- Clean and coat 6" diameter, partially underground wastewater line connecting the chemical facility to a public utility wastewater line
 - Line was heavily corroded after more than 20 years in service
 - Complex geometries consisting of 12-foot elevation change from road grade to underground and three 90° elbow joints
 - Excavation only possible at terminal section of pipe because line travelled underneath chemical transportation infrastructure which could not be disturbed during process

- Oceanit and its application partner completed cleaning and coating of the section within two days, and the line was returned to service within one week
- Pipe surface was cleaned, degreased, and coated with DragX™ to desired specifications using pipe pigging process
